REPORT OF INVESTIGATION

Surface Nonmetal Mine  
(Sand and Gravel)

Fatal Falling Material Accident  
November 10, 2006

Seppi Brothers Concrete Products Corporation  
Jammer Lake Pit - Virginia  
Virginia, St. Louis County, Minnesota  
Mine I.D. No. 21-00880

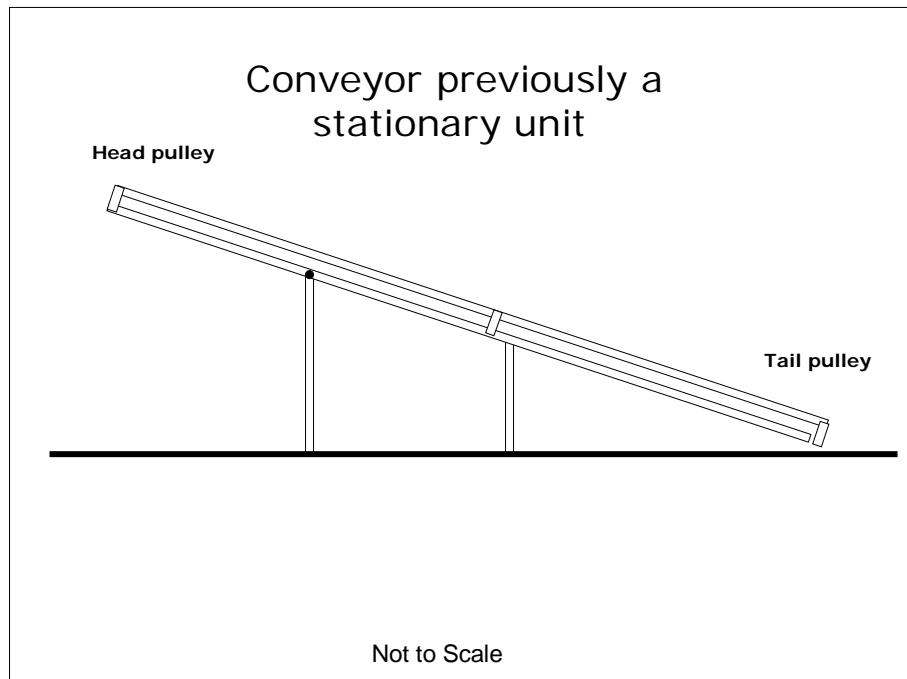
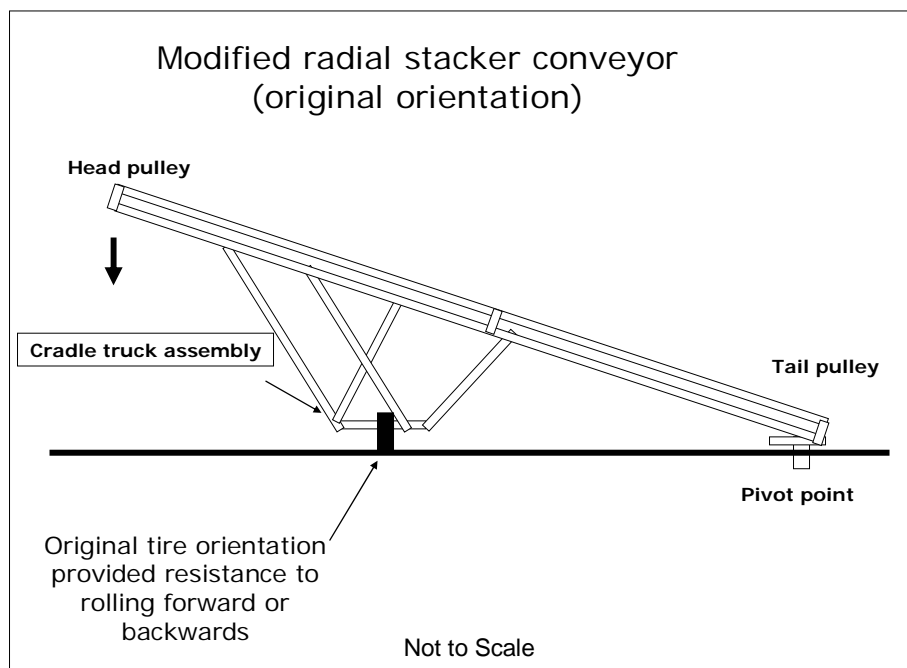
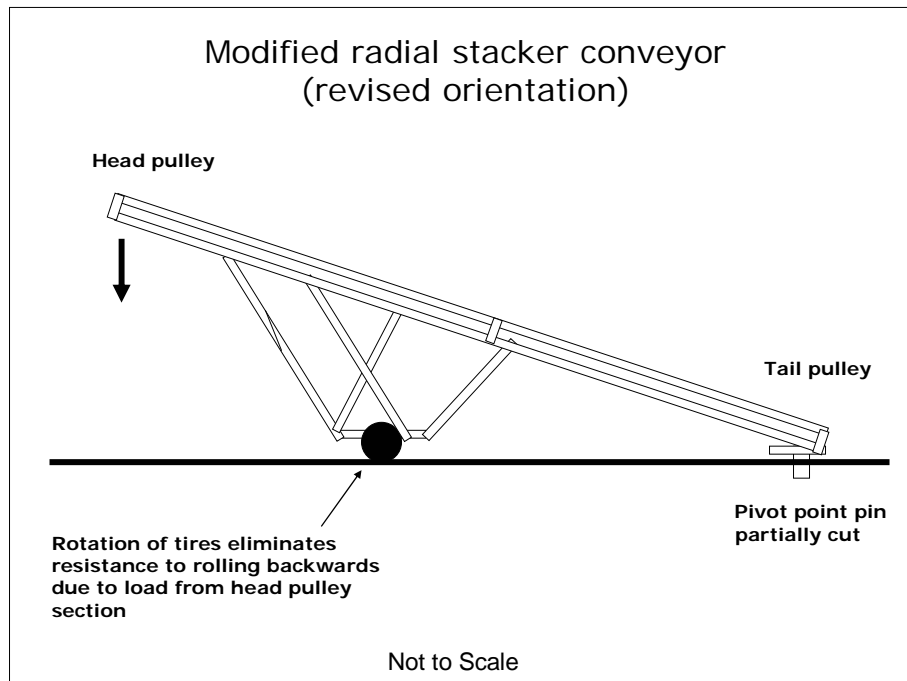
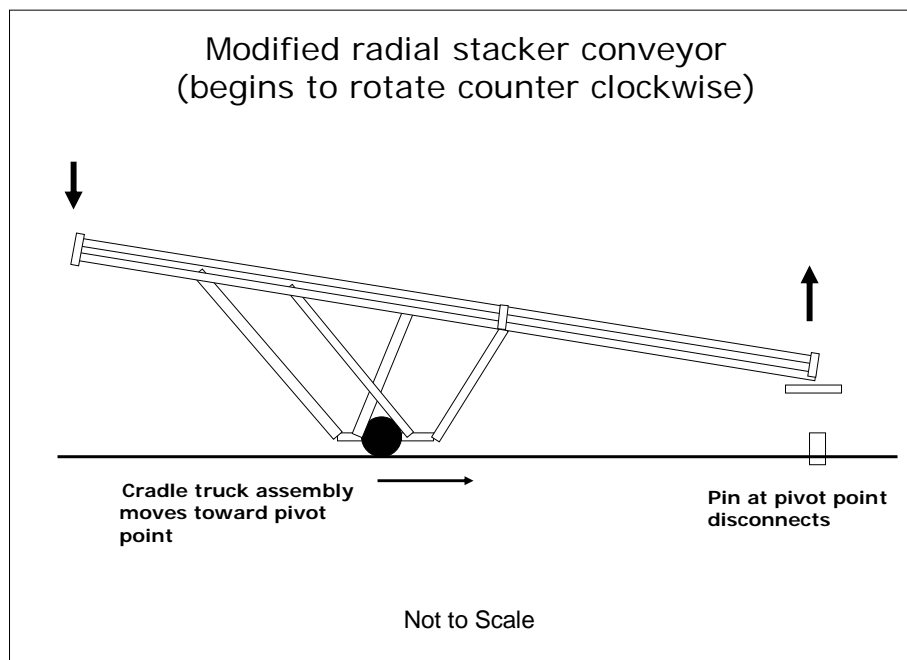
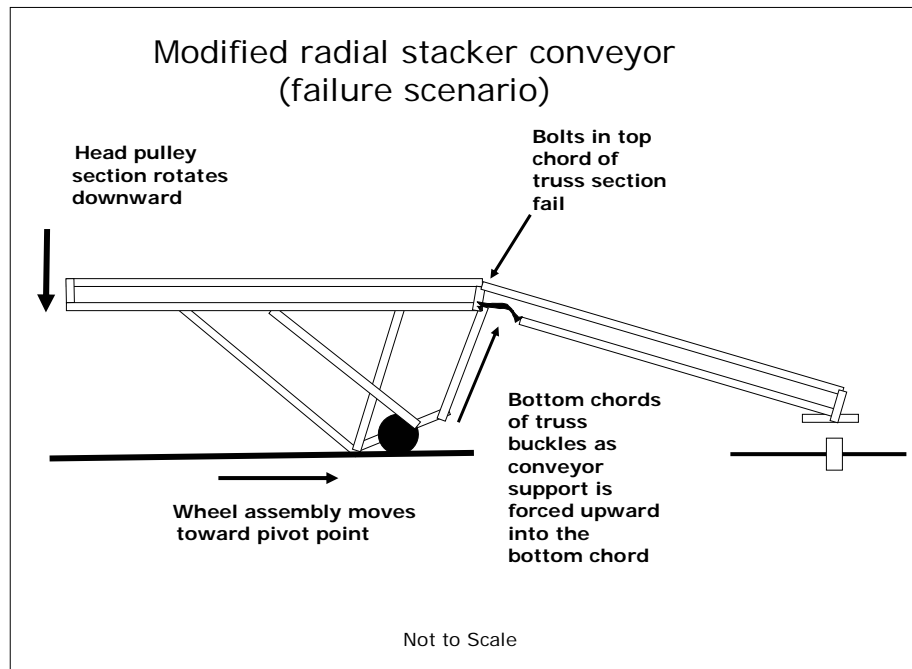
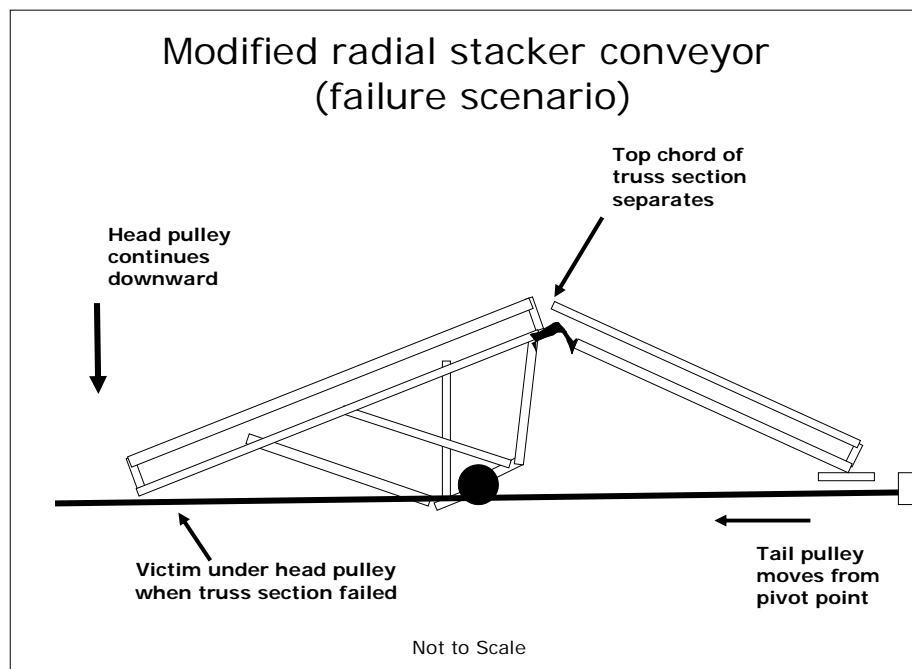
The modified radial stacker conveyor failed as follows: (see Appendix B)

- The weight associated with the head pulley (1,800 pounds) and the cantilevered portion of the conveyor truss sections located at the head section created a downward force on the front support arm of the cradle truck assembly.

- The head section and cantilevered portion of the conveyor deflected downward due to the configuration of the conveyor structure and loads involved. This movement caused the front support for the “V”-shaped support framework to push downward.

- The wheels allowed the support framework to rotate so the rear support pushed upward.
- The load from the cantilevered portion of the conveyor, including the head pulley, was transmitted into the bottom chord of the conveyor truss.

- As the bottom chord buckled, the top chord became overloaded in tension. As the head end of the conveyor dropped further, this ultimately caused the high strength bolts in the top chord of the truss to fail.

- Once the bottom and top chords of the conveyor truss failed, the head end of the conveyor could no longer be supported and it dropped to the ground.

Corrective Action: Management should implement a policy ensuring that modifications to equipment are made by following established engineering principles so hazards to persons are not created.

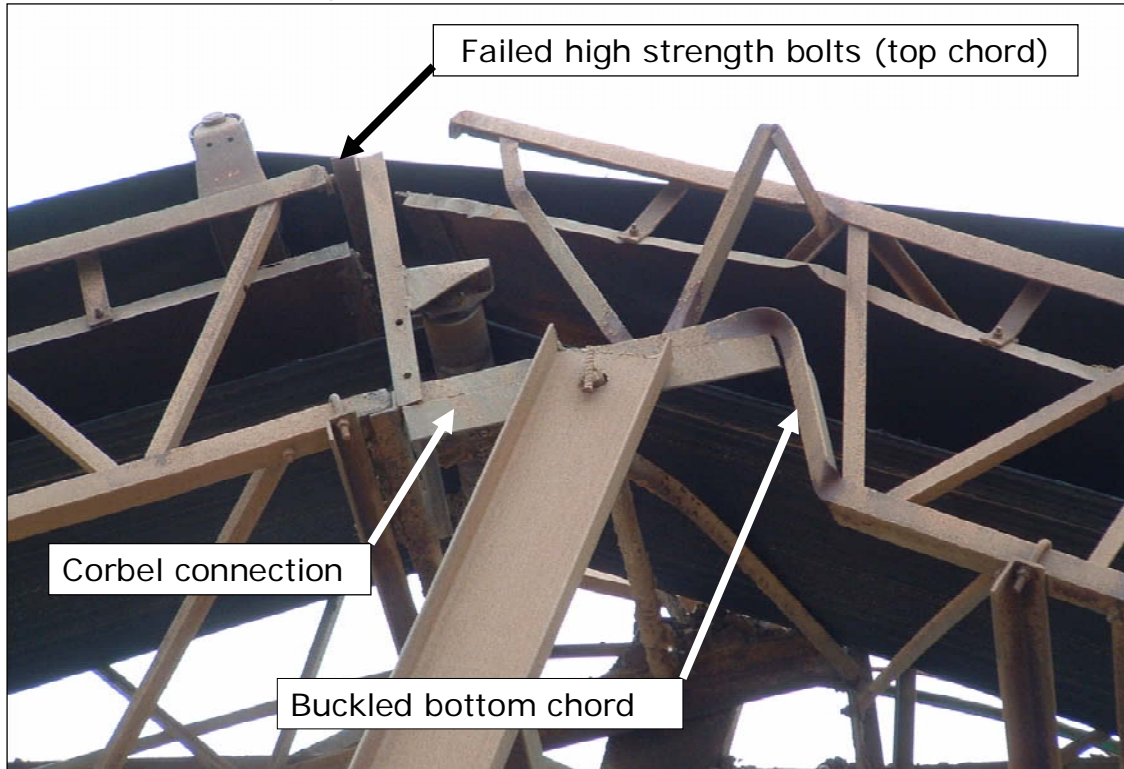
- The length and location of the corbel connection was not capable of distributing the load sufficiently over the bottom chord of the truss. This caused the bottom chord to buckle.

Close up of buckled bottom chord of conveyor section  
(Note: Length and location of corbel connection)
